Inspection Report

Inspector: Harry Ren
Inspection location: Dagang district, Tianjin City
Date of inspection: Sep.29, 2016

SGS order No.:	IN-SH-5802-16296				
Coordinator:	Betty Du		Telephone:	+86 (0)21 61196300	
Description of commodity (Name ,Model ,Quantity ...)					
Piles with coating, ϕ 356 x9mm x8000mm, total 108pcs					
Piles with coating, ϕ 356 x9mm x7500mm, total 138pcs					
Buyer(Name ,Address...)					
THE BUILDING PRODUCTS CO.LTD.					
P.O. BOX 50968					
JEDDAH 21432					
SADUI ARABIA TEL: 012 6823680/FAX:0126828352					
Seller(Name ,Address...)					
LIVART MARINE INDUSTRY CO.LTD					
RM B413, HENGYU CENTER, DENGJIANG ROAD, NAN SHAN DISTRICT.,SHENZHEN, CHINA					
T:+86-755-25578529					
L.C No.	W062840 Date:160830				
Nature of inspection:	Item	Satisfactory		Non conforming	
	Quantity check(not include weight check)	●

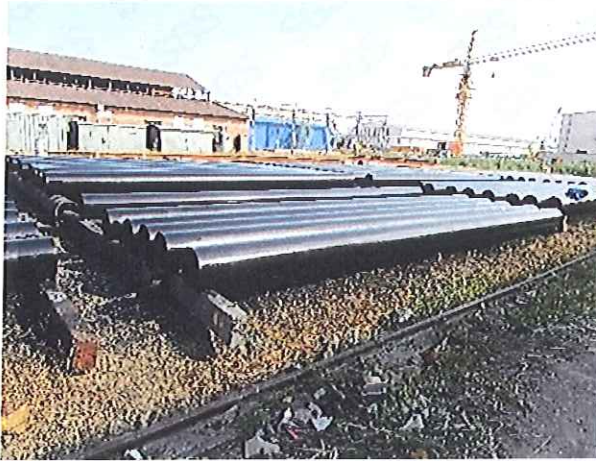
The actual quantity was in accordance with the requirement of packing list [Invoice No.:LVC160920] provided by client.

Fig.1 Quantity inspection

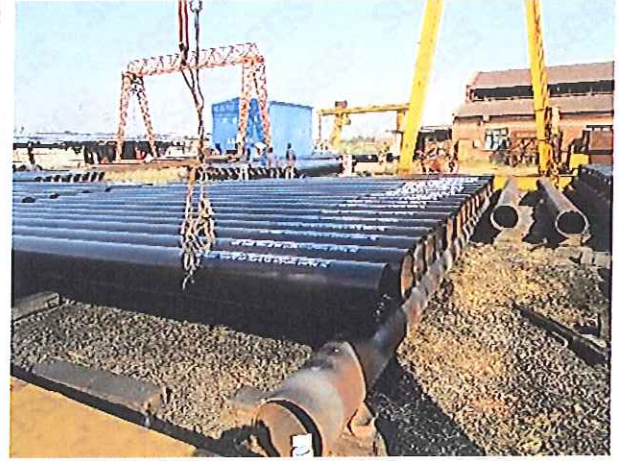
Fig.2 Quantity inspection

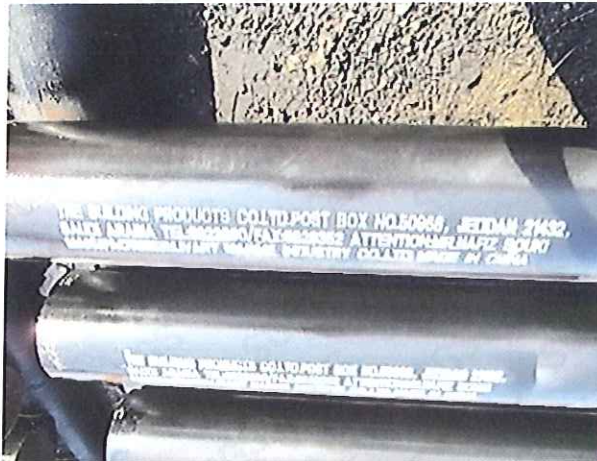
White paint mark was found on the external surface near one end, details as below,
THE BUILDING PRODUCTS CO.LTD.POST BOX NO.50968, JEDDAH 21432,
SADUI ARABIA TEL:6823680/FAX:6828352 ATTENTION:MR.HAFIZ SOUKI
MANUFACTURER:LIVART MARINE INDUSTRY CO.,LTD MADE IN CHINA

Marking check is acceptable according to packing list [Invoice No.:LVC160920].

Fig.3 Marking inspection

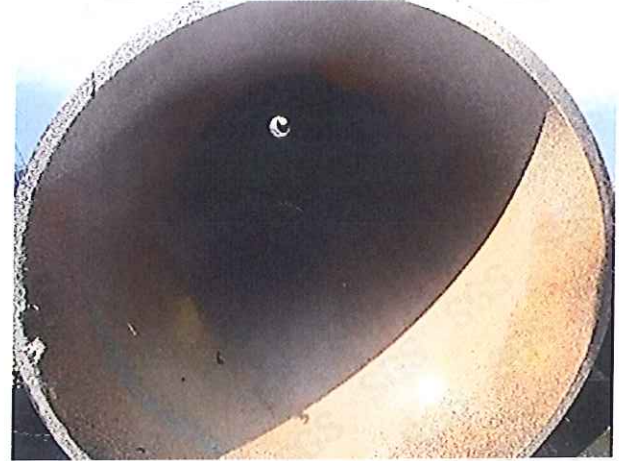
Visual quality inspection was performed by SGS inspector on site; found the cargos were welded pipes actually, and the pipes were plain ends without beveling, the weld seams were found on the external and internal surface. The external surface of pipes was painted with black paint. The coating was clean and smooth. The internal surface of pipes was not painted; slight nature rust was found during the inspection. No other defect was found during the inspection, such as deformation, crack, pit, etc.

Fig.4 Visual quality for internal surface

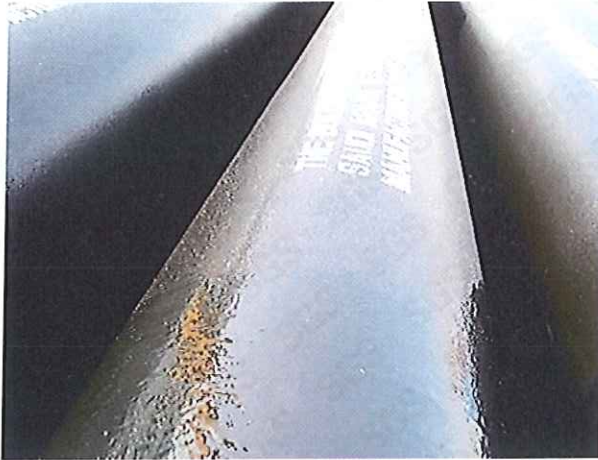
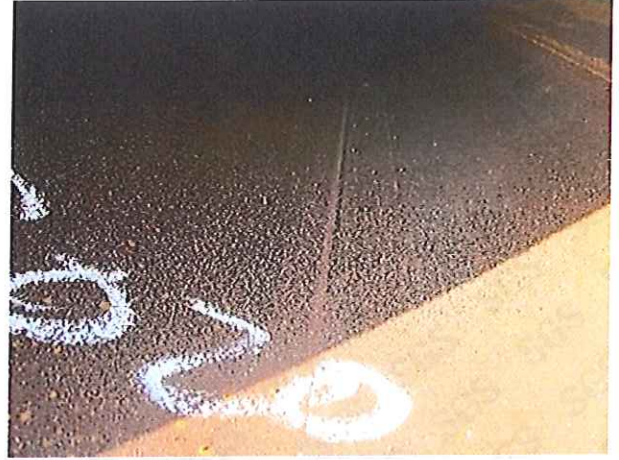
Fig.5 Visual quality for weld seams

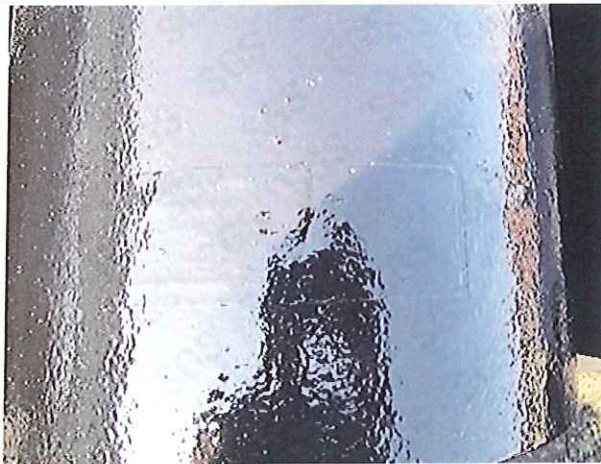
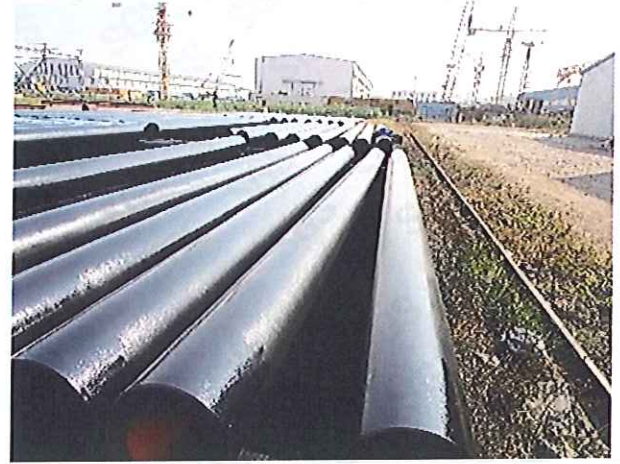
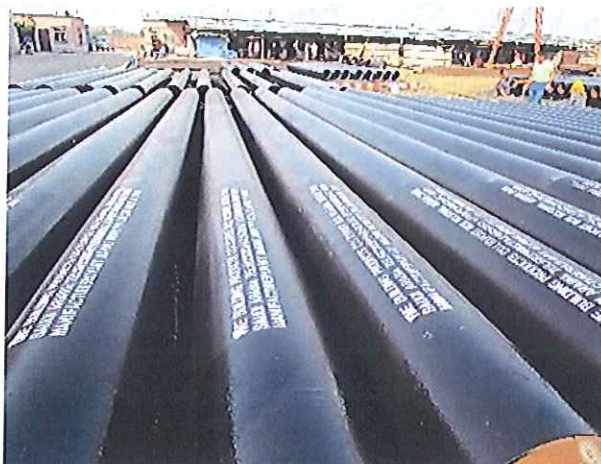
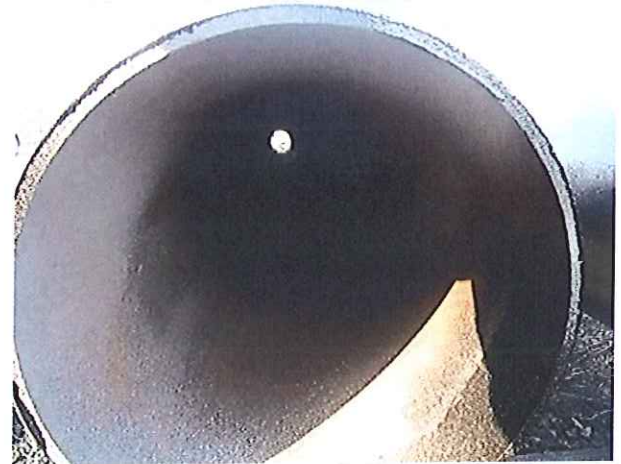
Fig.7 Visual quality

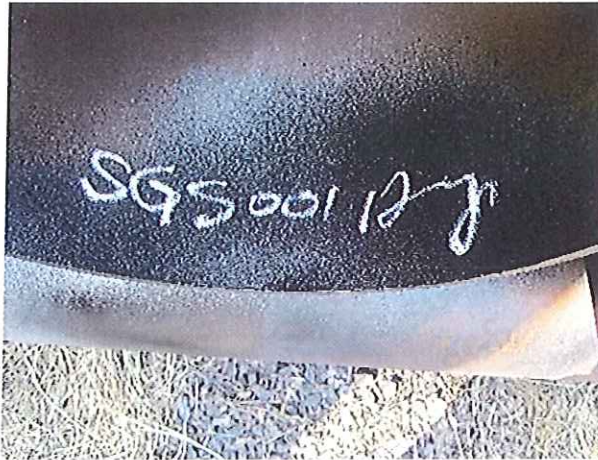
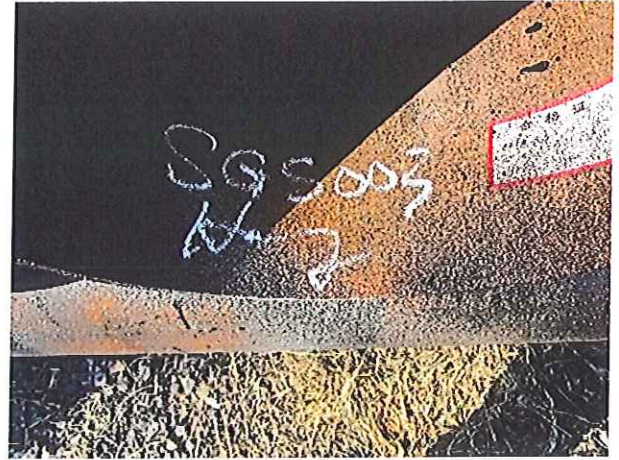
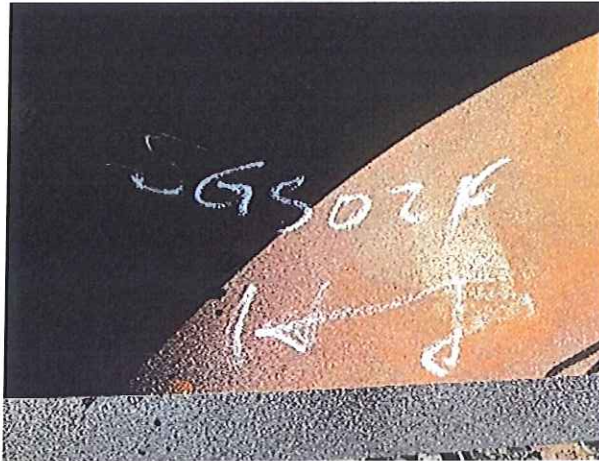
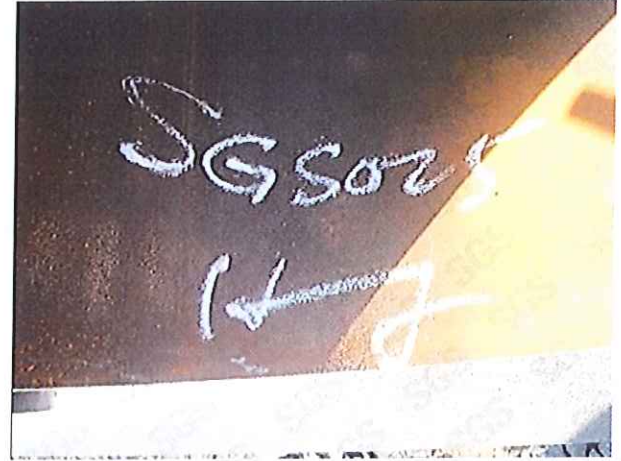
- 1) As per the requirement on drawing date 2016-8-29, no tolerances of outer diameter, wall thickness & length were required.
- 2) The inspected pipes were marked by SGS inspector on internal surface near one end, pictures were attached for reference.
- 3) The Act. Values were measured with coating.
- 4) The result of dimension inspection was subjected to buyer's evaluation.

Fig.11 SGS Marking

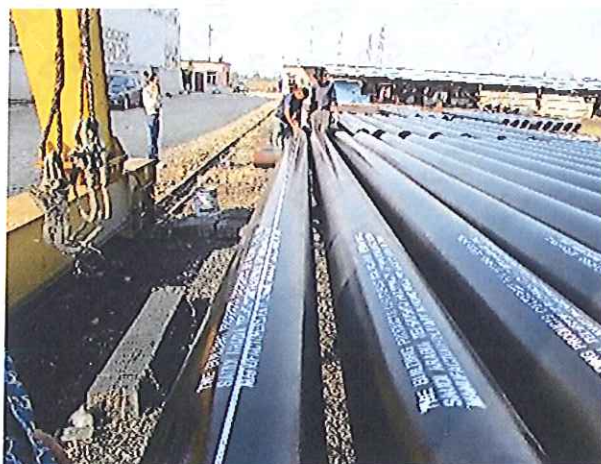
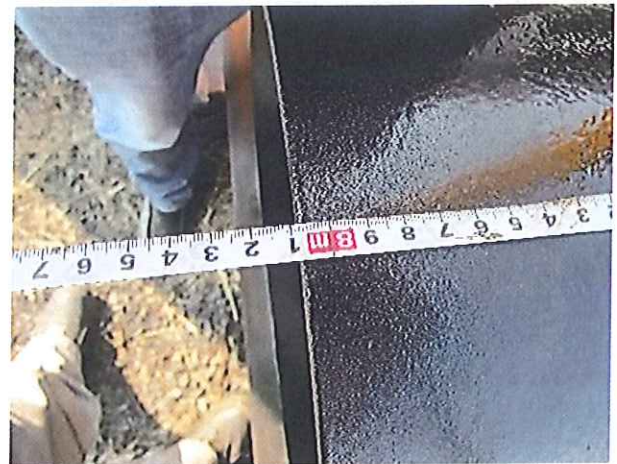
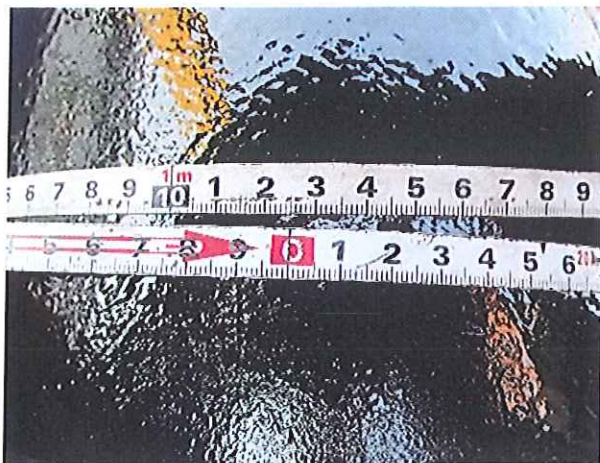
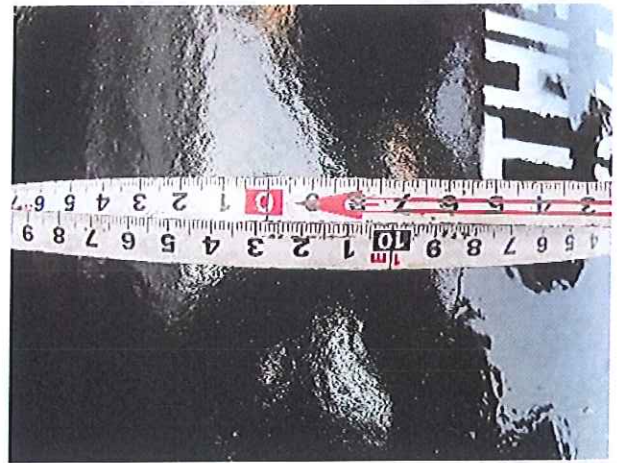
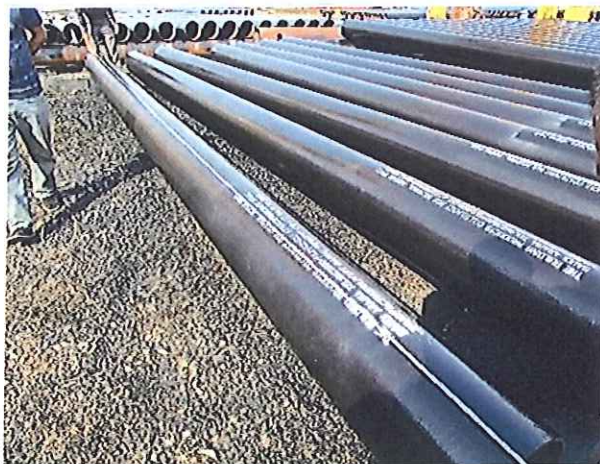
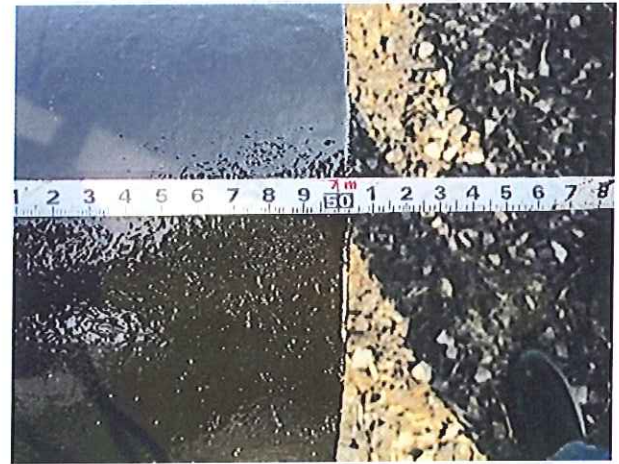
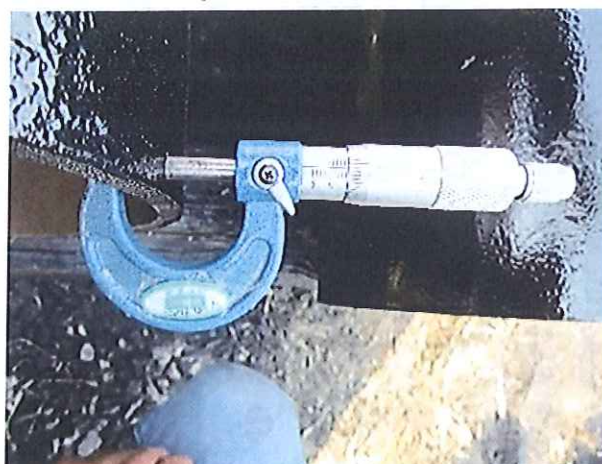
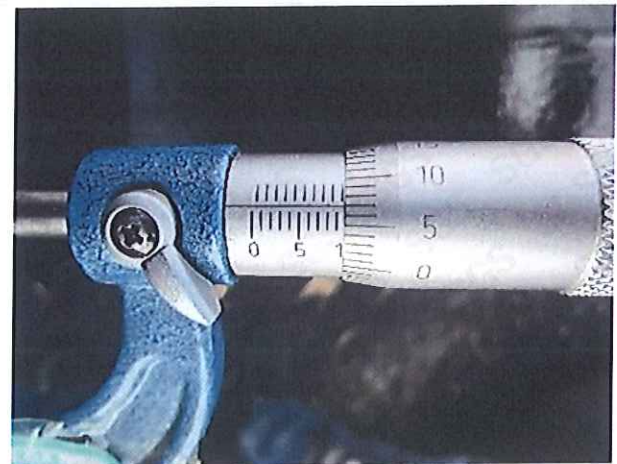
Fig.15 Dimension check

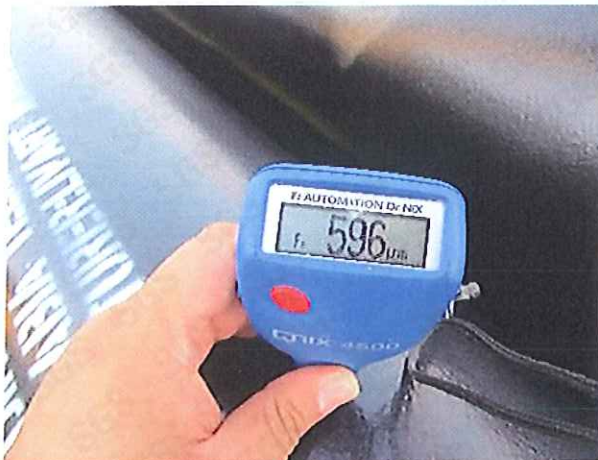
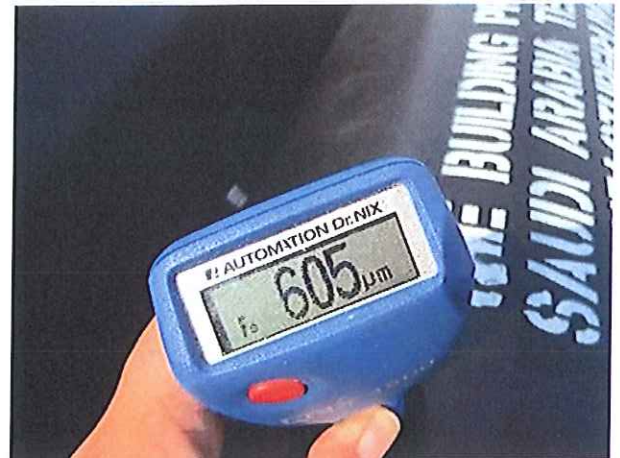
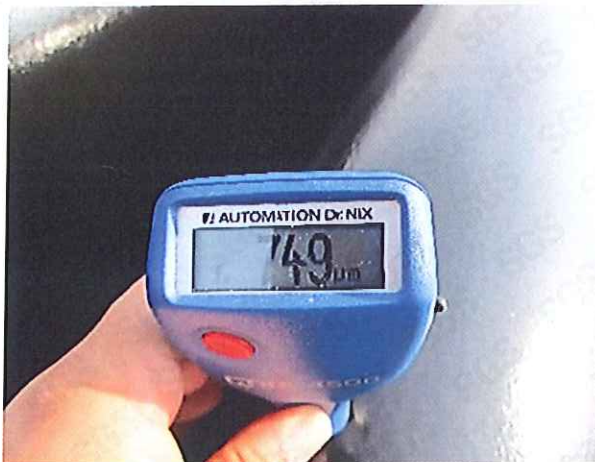
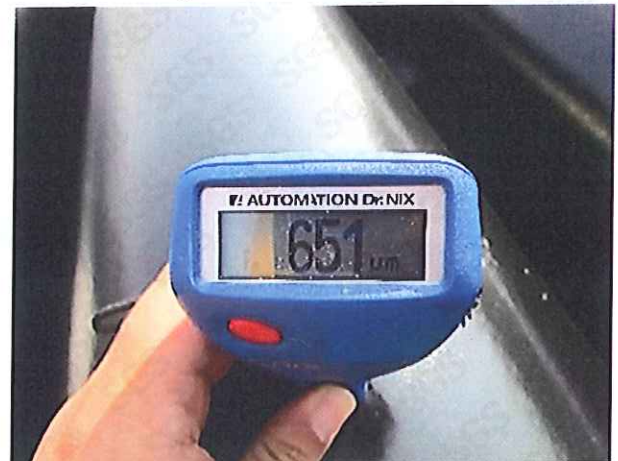
- 1) 10points were selected randomly along the full length for coating thickness measurement.
- 2) The UV resistance polyurethane coat was applied to the whole length of the pipe.
- 3) The actual thickness value was in accordance with the requirement specified in Drawings, date 2016-8-29.
- 4) Due to the pipes were finished coating when SGS inspector arrival at the inspection site, only sum thickness of coating could be checked.
- 5) The result of coating thickness inspection was subjected to buyer's evaluation.

Fig.23 Coat thickness check
