Test Report No. TAOEC2309054106 A01 Date: 04 Jan 2024 Page 1 of 4

Sample Name: Die bonding paste

EN-4900GC Model No.:

Test Method: With reference to EN 14582: 2016, analysis was performed by Ion Chromatograph (IC).

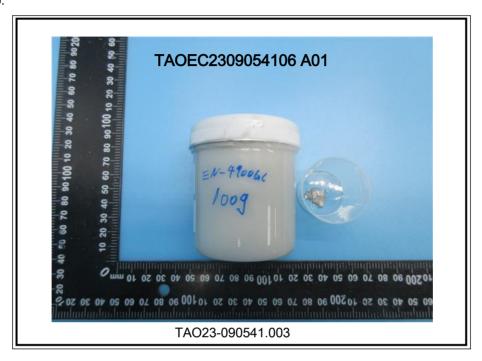
Sample photo:

Specimen No. SGS Sample ID **Description** TAO23-090541.003 SN₁ Gray mud
